## Volcanic ash impacts on critical infrastructure

### ABSTRACT

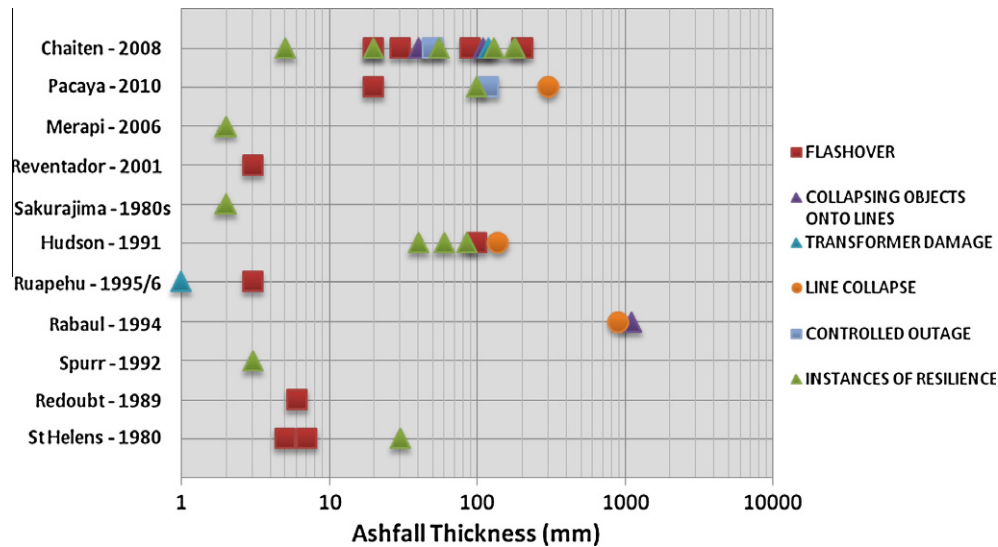
Fig. 4. Summary of volcanic ash impacts to electrical systems following different volcanic eruptions since 1980.

Volcanic ash can cause a range of impacts on electrical generation, transmission and distribution networks (Fig. 4). The main impacts are: (1) supply outages from insulator flashover caused by

The main impact of volcanic ash fall on transmission and distribution lines is likely to be insulator flashover. Lines may also be damaged by heavy ash falls onto overhanging tree branches, particularly if weather conditions are also snowy (Fig. 4 and Table 3).

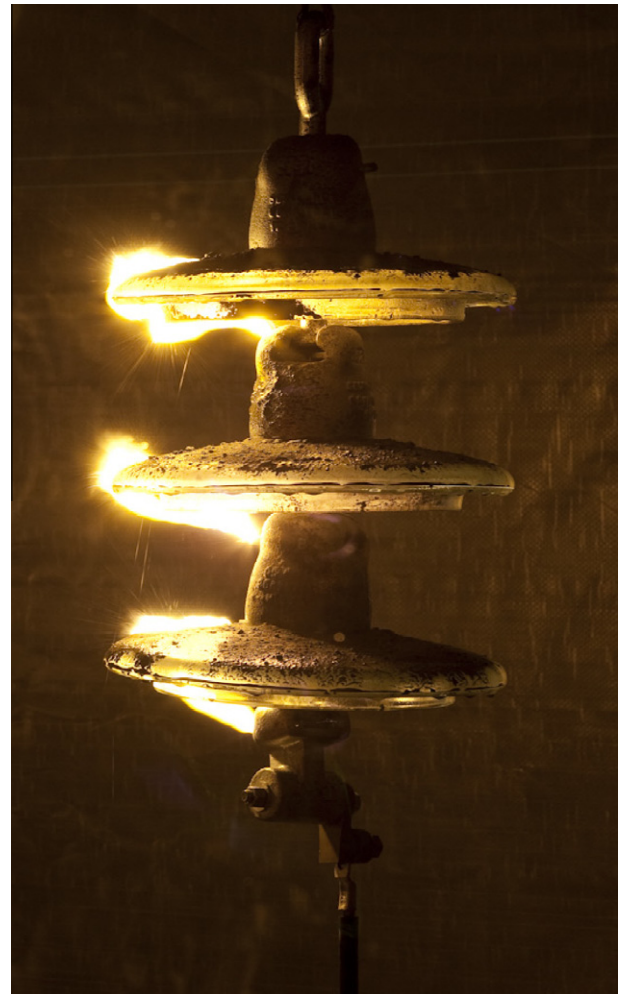
Fig. 5. An example of a flashover (three faults) on a glass string insulator. The insulator has been coated with 3 mm of wet volcanic ash. Flashover occurred at ~40 kV (insulator string design voltage 40 kV).

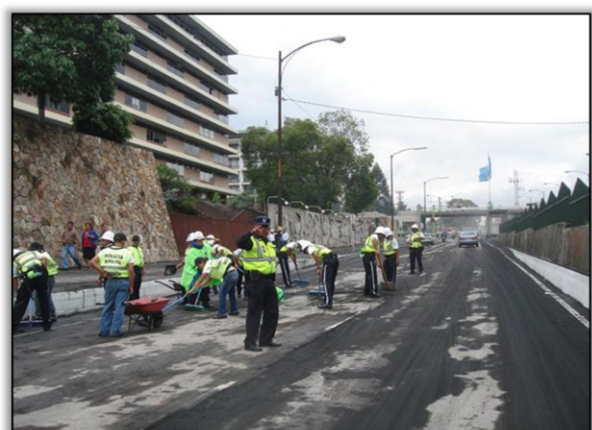
**Fig. 9.** Cleanup of Guatemala City roading network (photo credit: Ing. Alvaro Hugo Rodas Martini, Municipality of Guatemala City, 2010).
